⑨ **BUREAU OF SHIPS GROUP**  
**TECHNICAL INSPECTION REPORT.**

⑥ **OPERATION CROSSROADS.**  
**U.S.S. RHIND (DD 404)**  
**TEST ABLE [U].** ⑧

**OPERATION CROSSROADS** **CONFIDENTIAL**  
Security Information

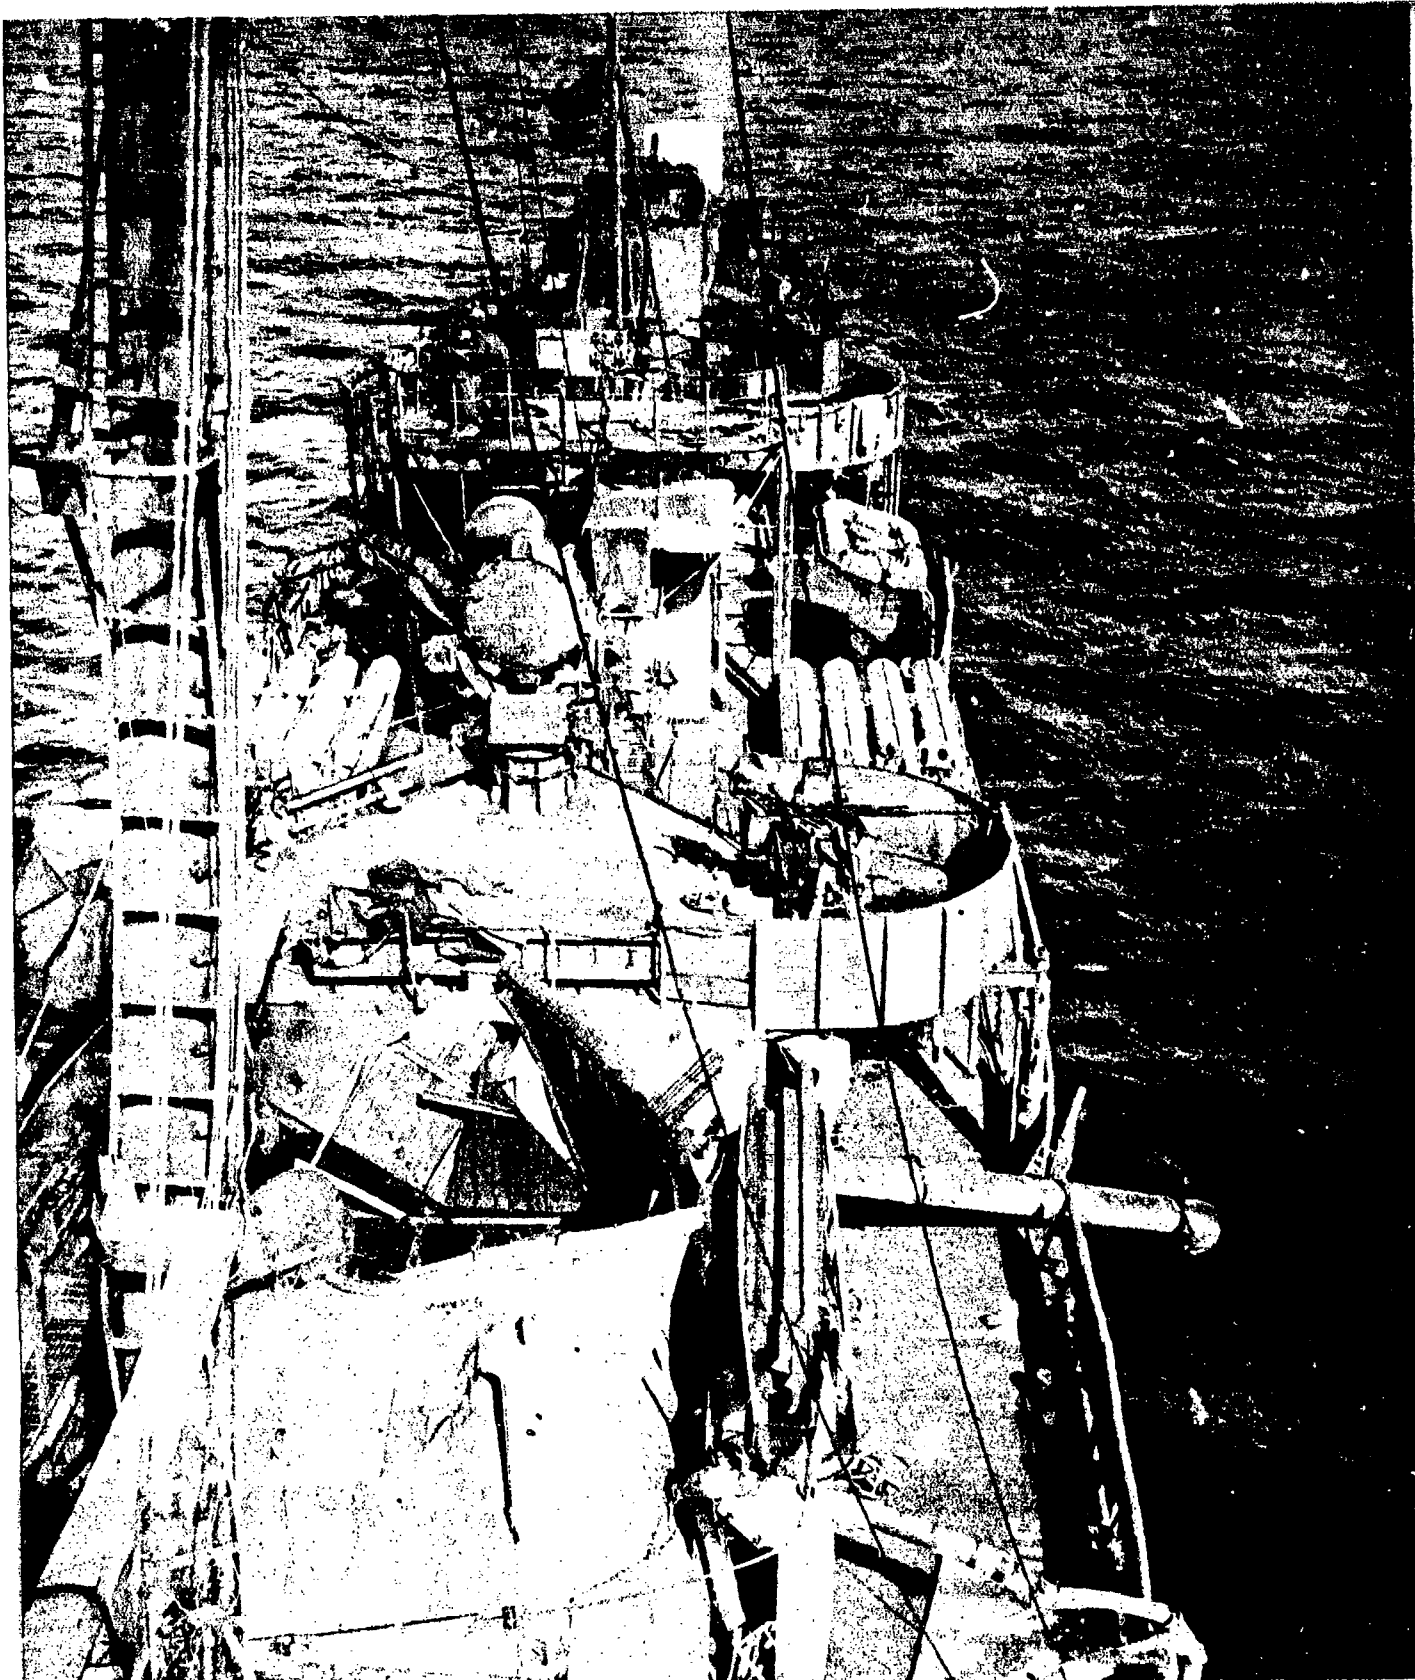
AA-CR-58-2010-9. General view of damage looking aft the length of the ship from the port side of the navigating bridge.

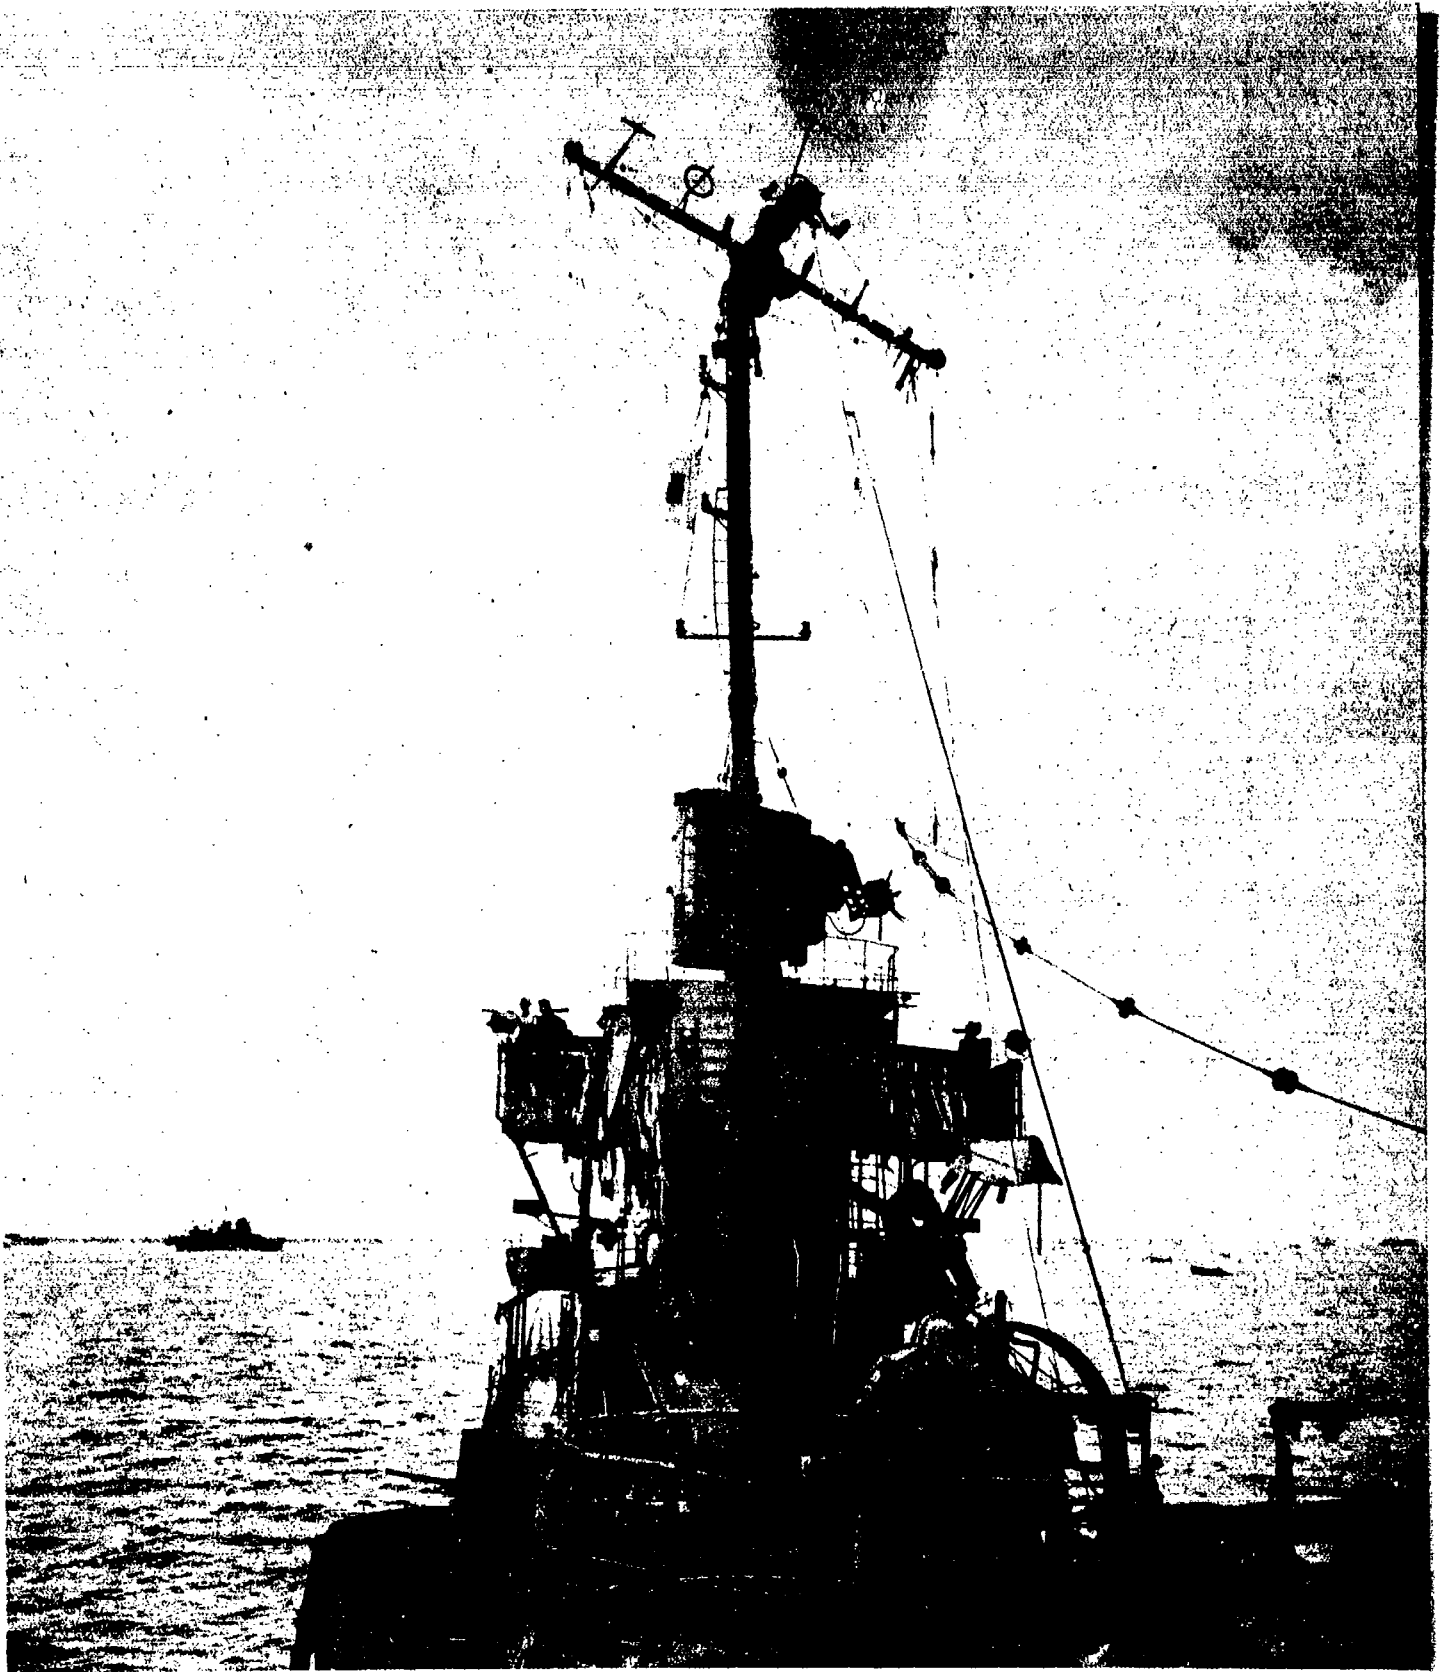
There is a general failure throughout of bulwarks, 20mm gun shields, life lines, stanchions, and other light metal work. Ladders are bent, twisted, and torn from their fastenings, but in no case are the ladders unusable. Catwalks, too, are distorted. Especially the catwalk from the forecastle deck, aft, which is almost impassable in places. All radar antennae are either down or broken. Whip antennae, although broken, bent, or twisted seem to stand up best and are still serviceable after the test. (Photographs 2005-5, page 68, 2010-11, page 69, 1772-1, page 70, 1771-11, page 73, 2005-3, page 74, 2010-10, page 75, 2010-8, page 76, 2010-9, page 77, 2003-11, page 78, 2003-10, page 79, 2003-2, page 80, 1817-3, page 81.

AA-CR-58-2003-11. View looking forward from after deck house showing damage amidships.

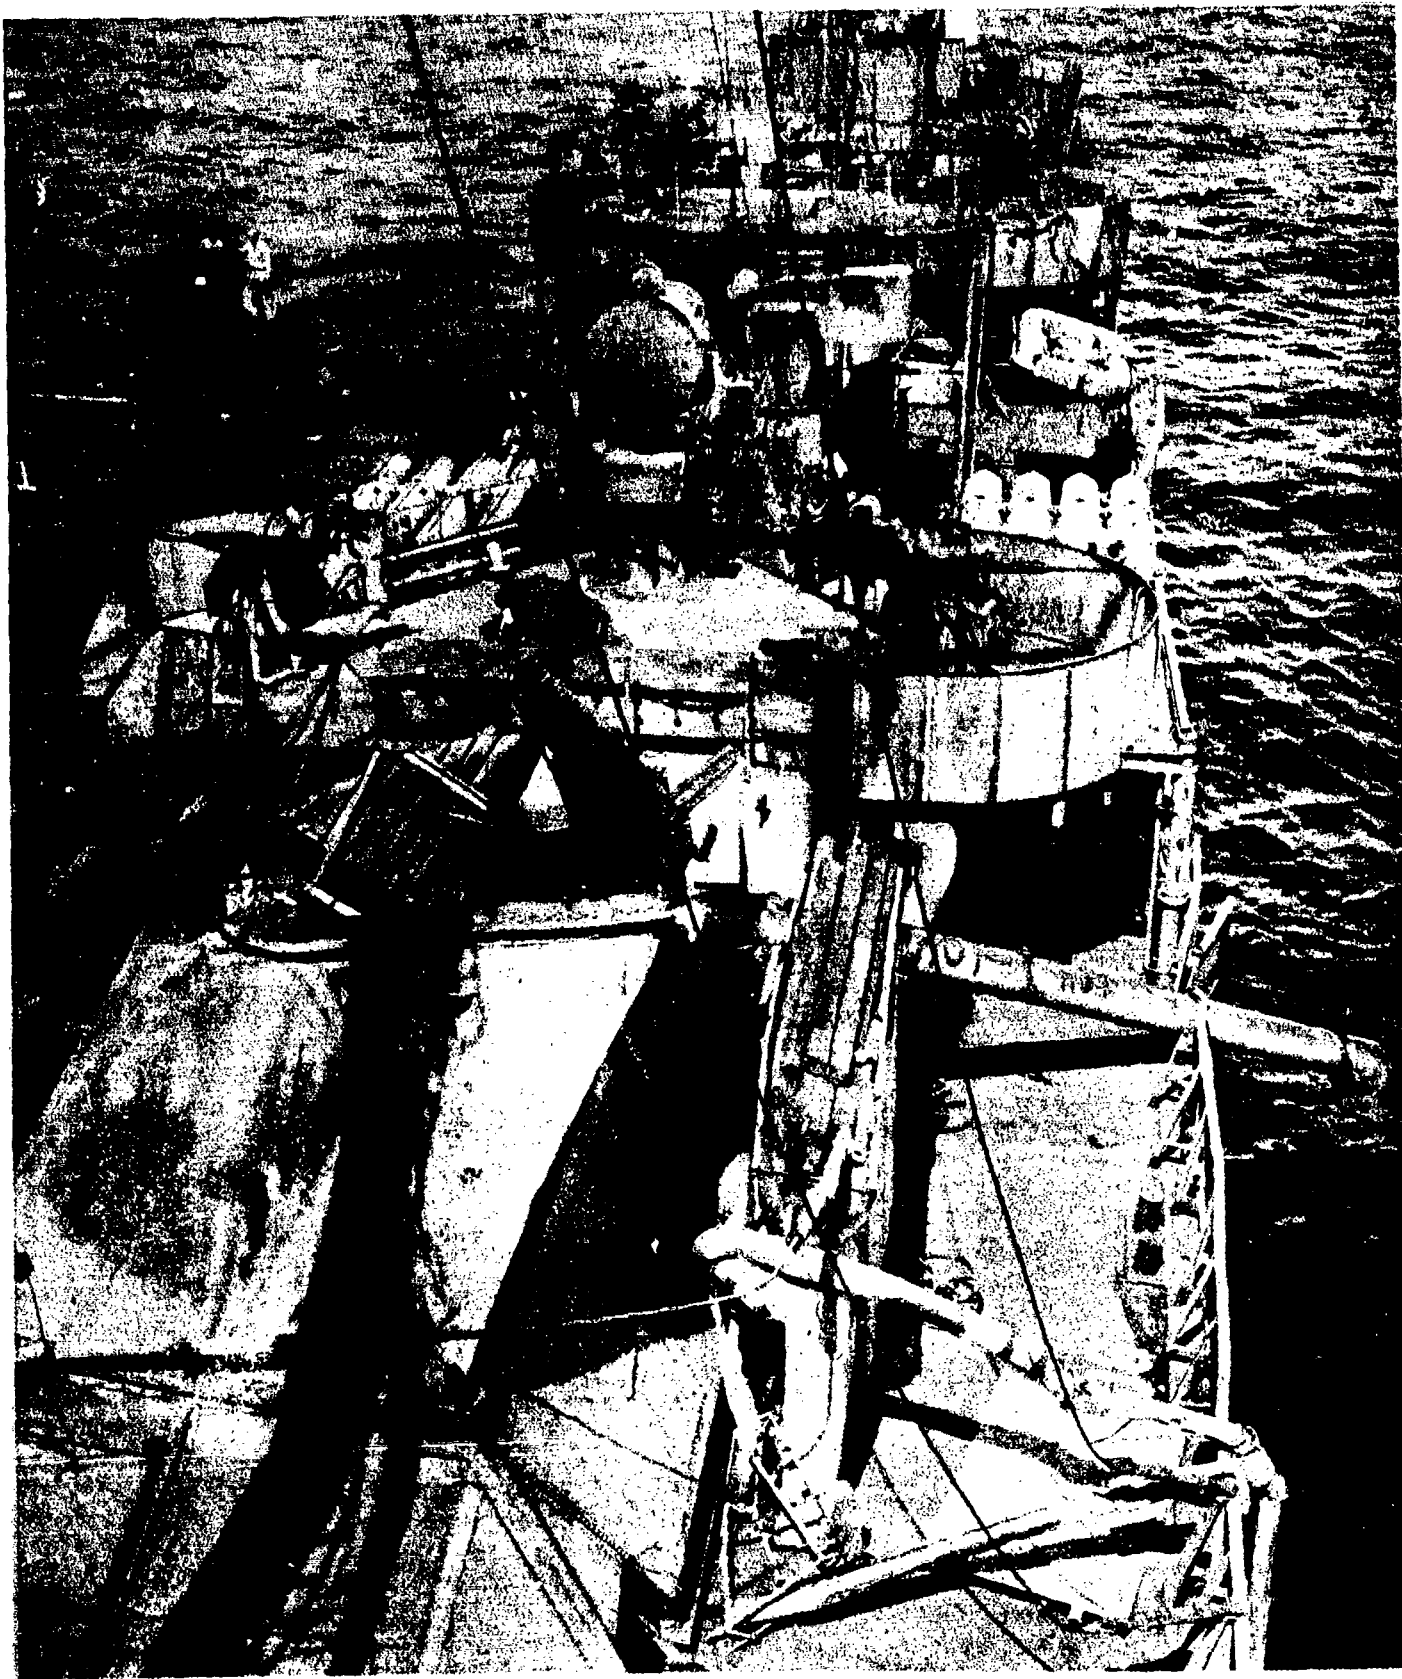
AA-CR-58-2003-10. View looking aft from port side of navigation bridge.

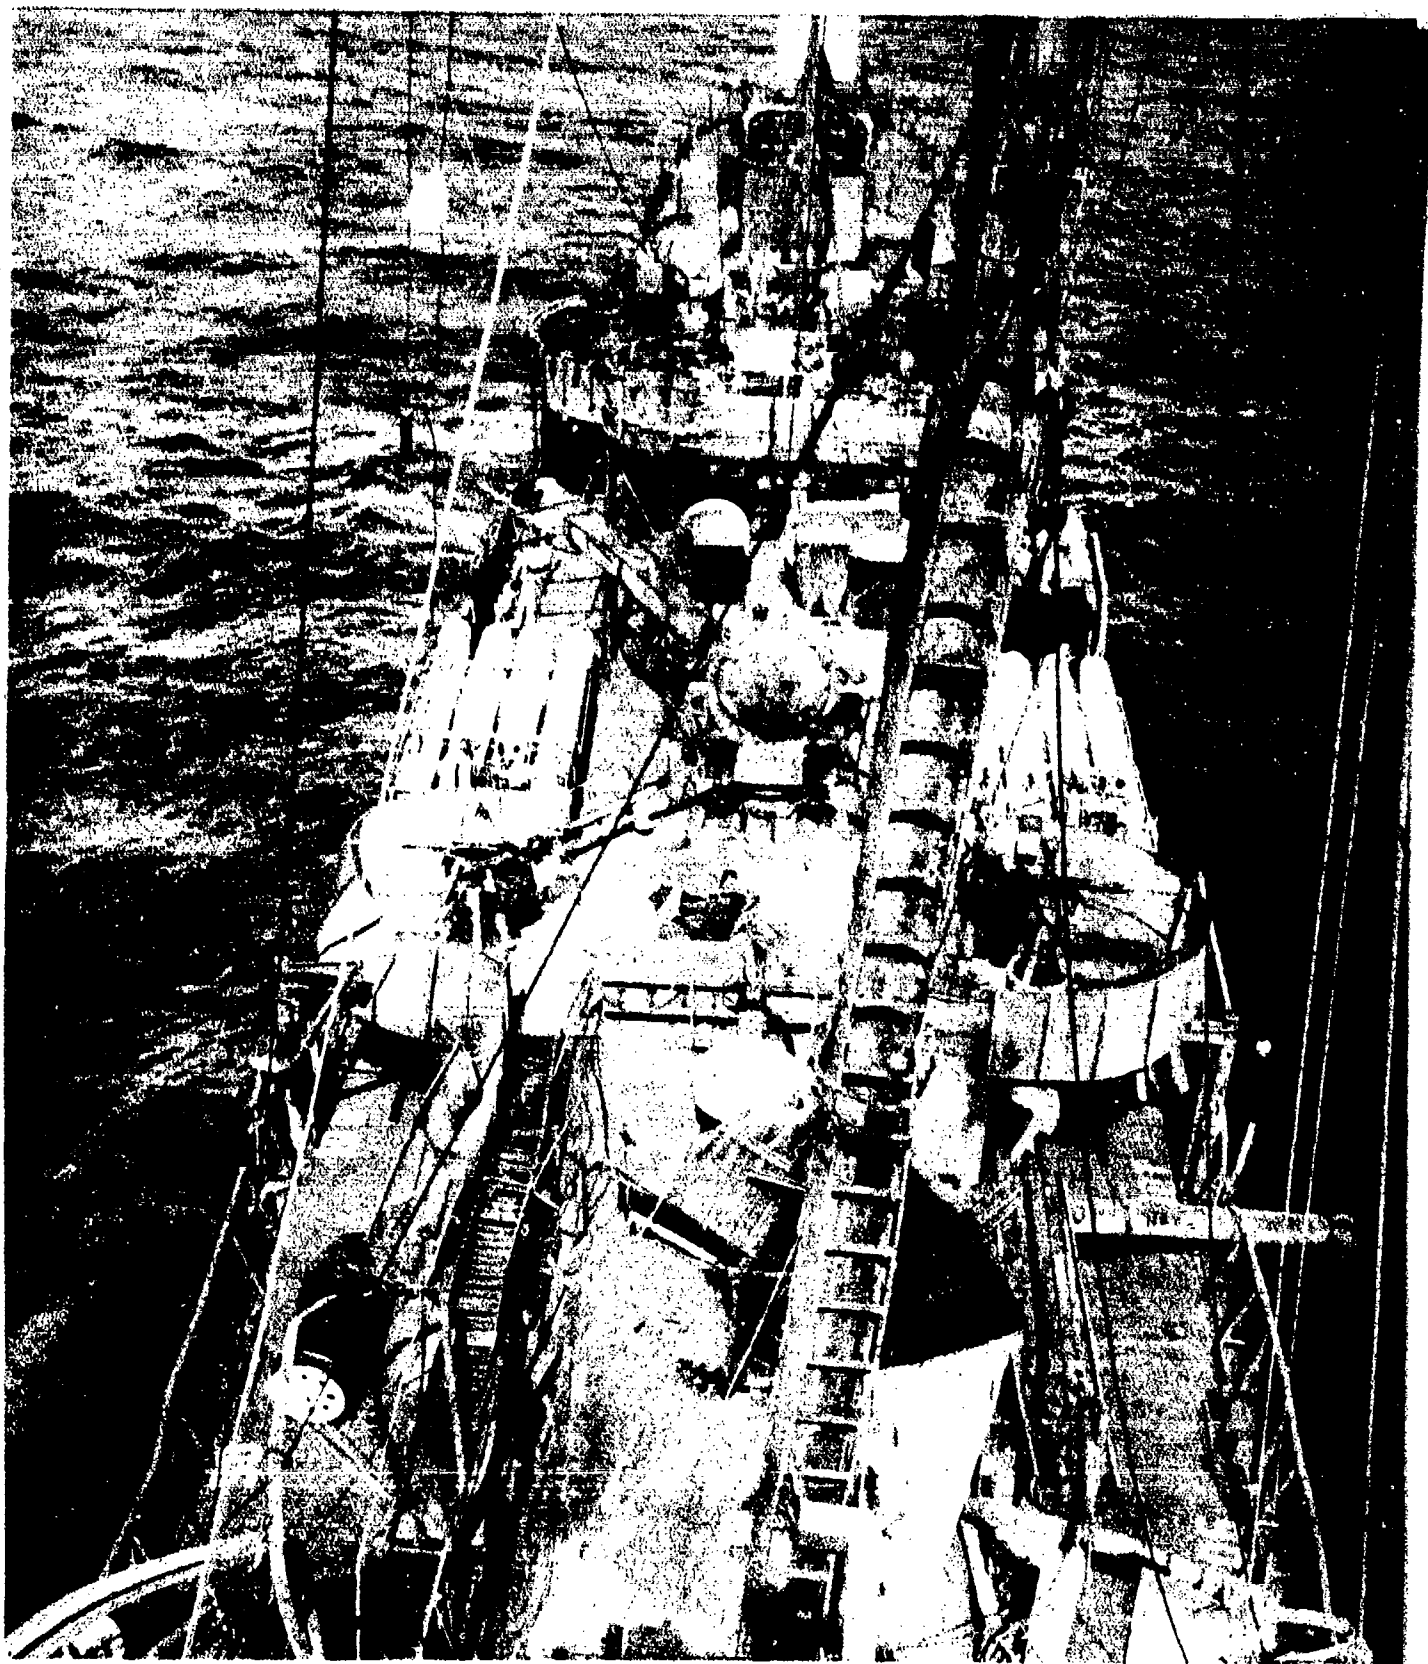
The foremast is severely damaged and twisted, rendering inoperable all radar antennae not torn off. The wave guide on the after side of the mast is broken and twisted. The foremast is bent aft and to port at the top of the main deck supporting brackets. About twelve feet above this point the mast is further bent in the same direction. A third kink occurs just above the padeyes to which the lower mast guys are secured. The forward guys are parted. The after guys have about 14 inches of slack. There is a further sharp bend just below the yardarm level. The yardarm is askew with respect to the rest of the mast. All signal halyards are either burned completely or torn off. (Photographs 2003-11, page 78 , 2003-2, page 80 , 2003-4, page 83 , 2200-2, page 84 , and 2200-9, page 85 ).

AA-CR-58-2003-2. View looking aft the length of the ship from sky lookout forward.

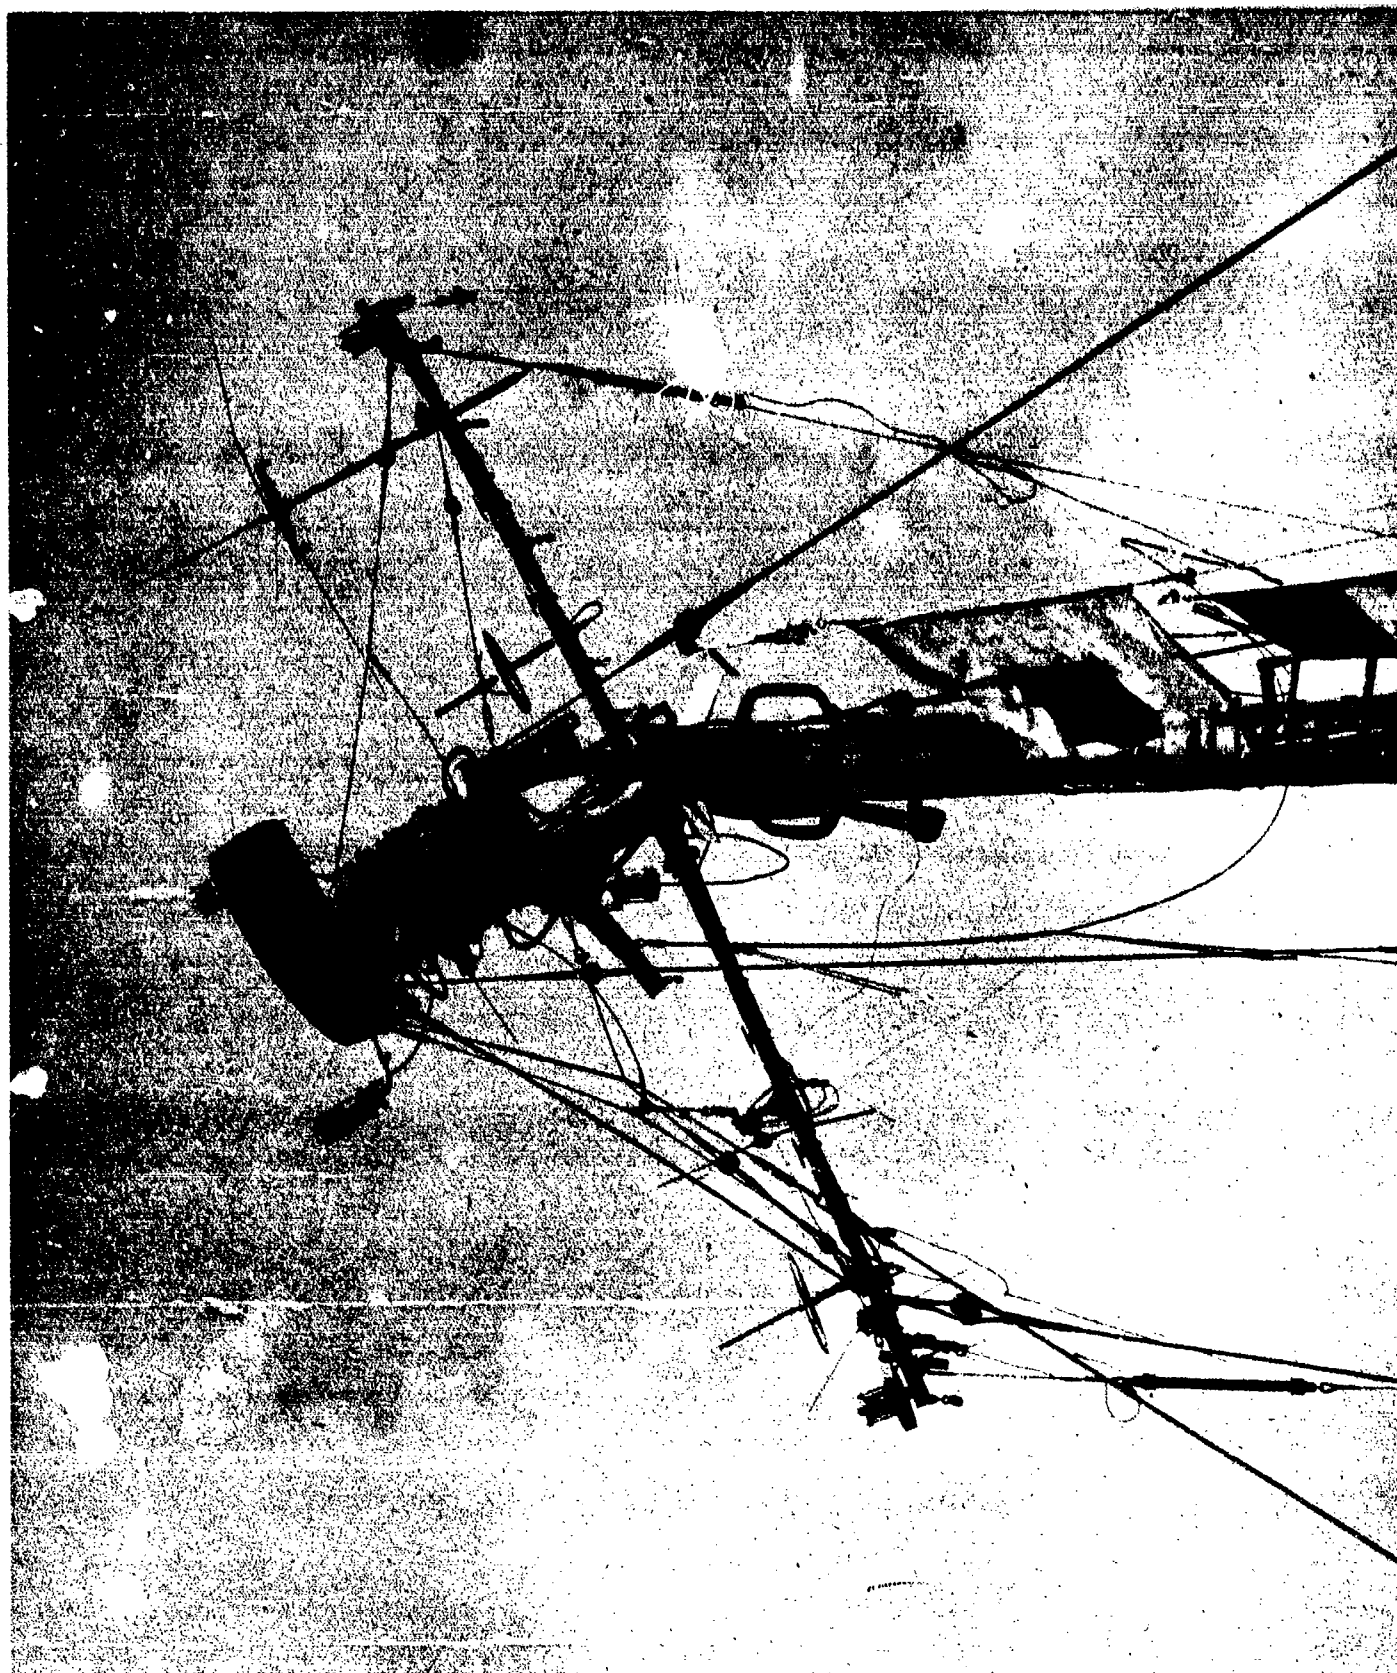
AA-CR-58-2003-4. View of foremast top from director platform.

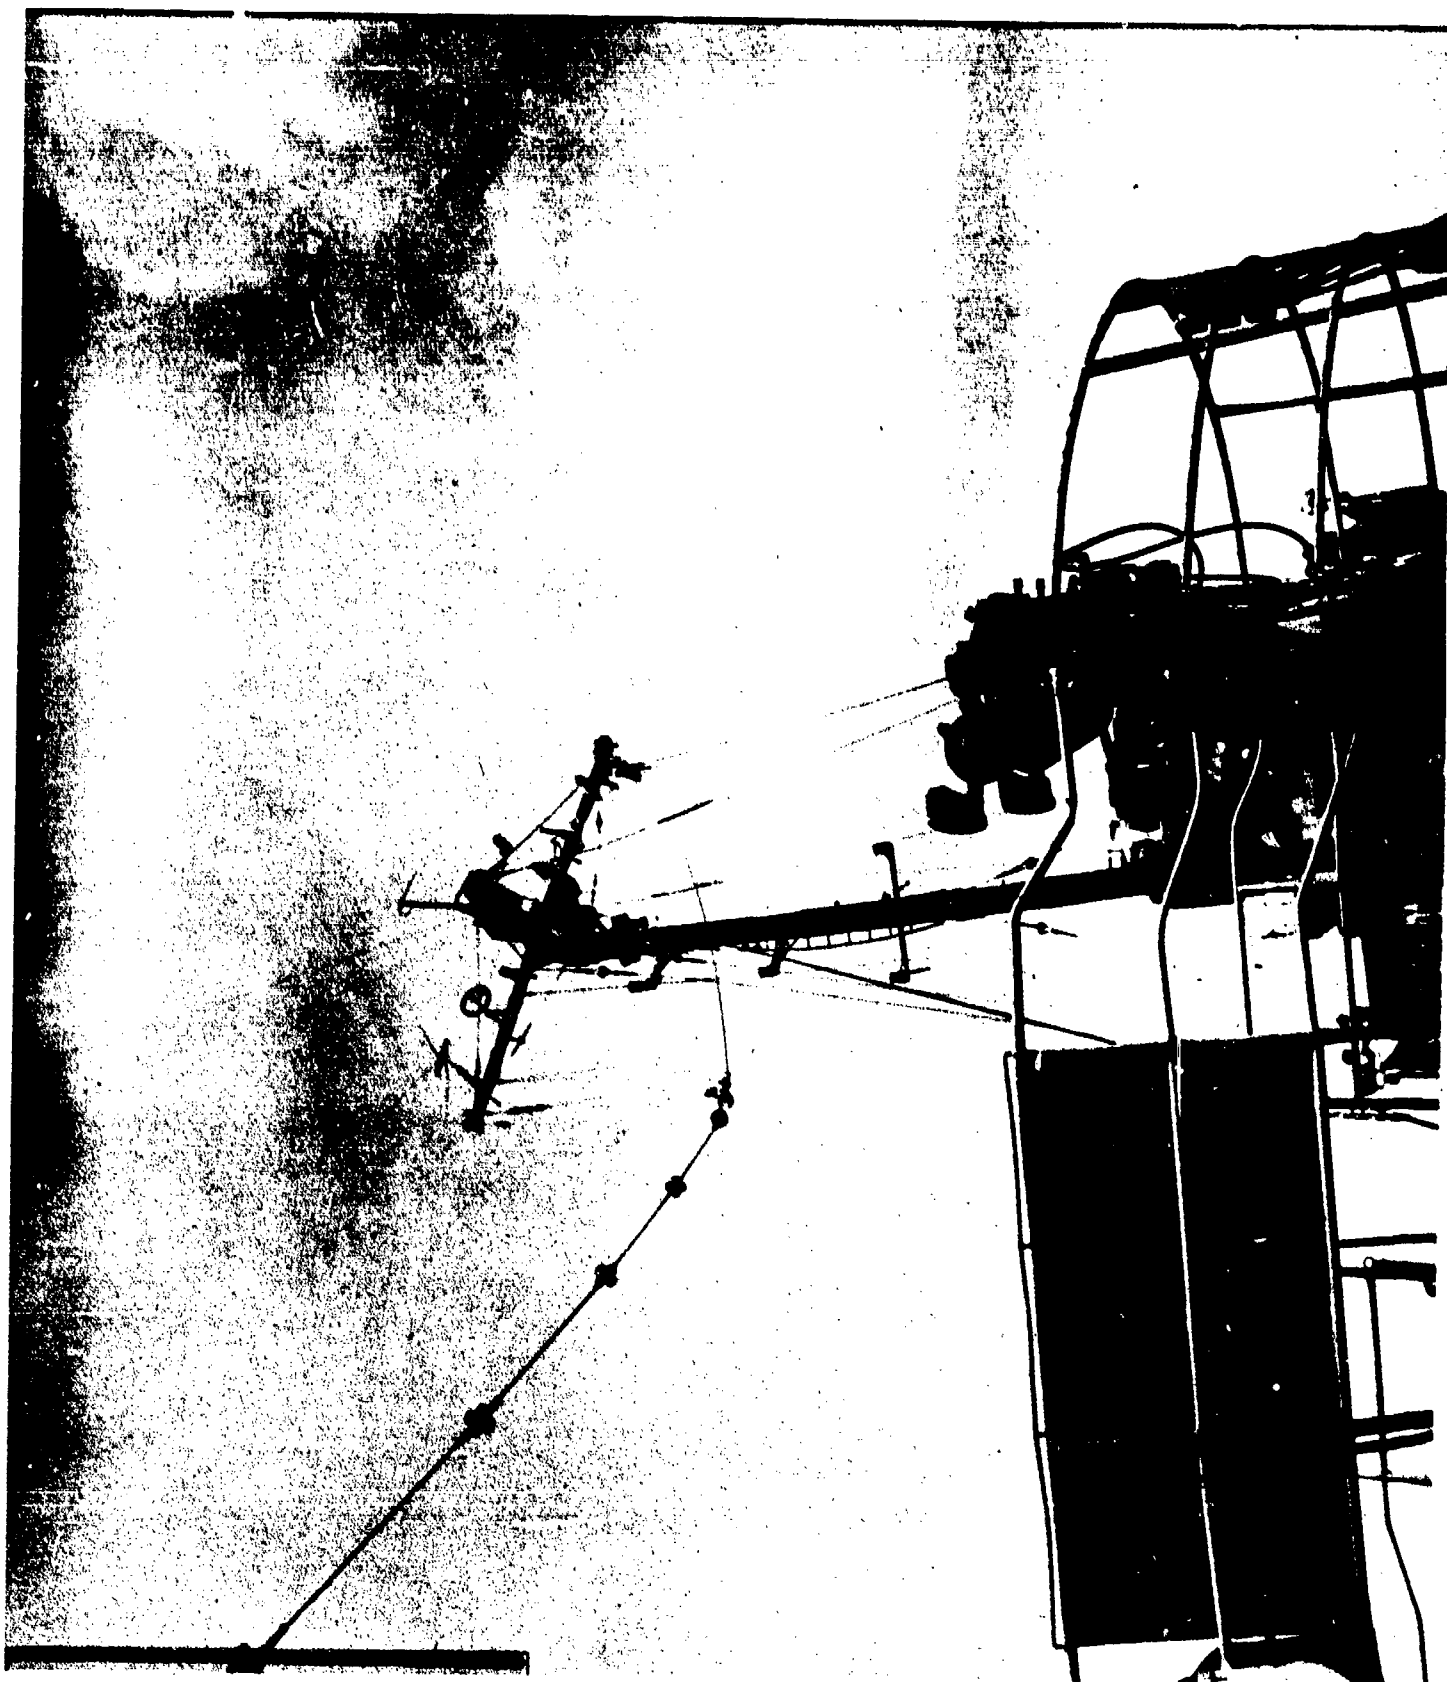
AA-CR-100-2200-9. View of foremast damage looking forward.

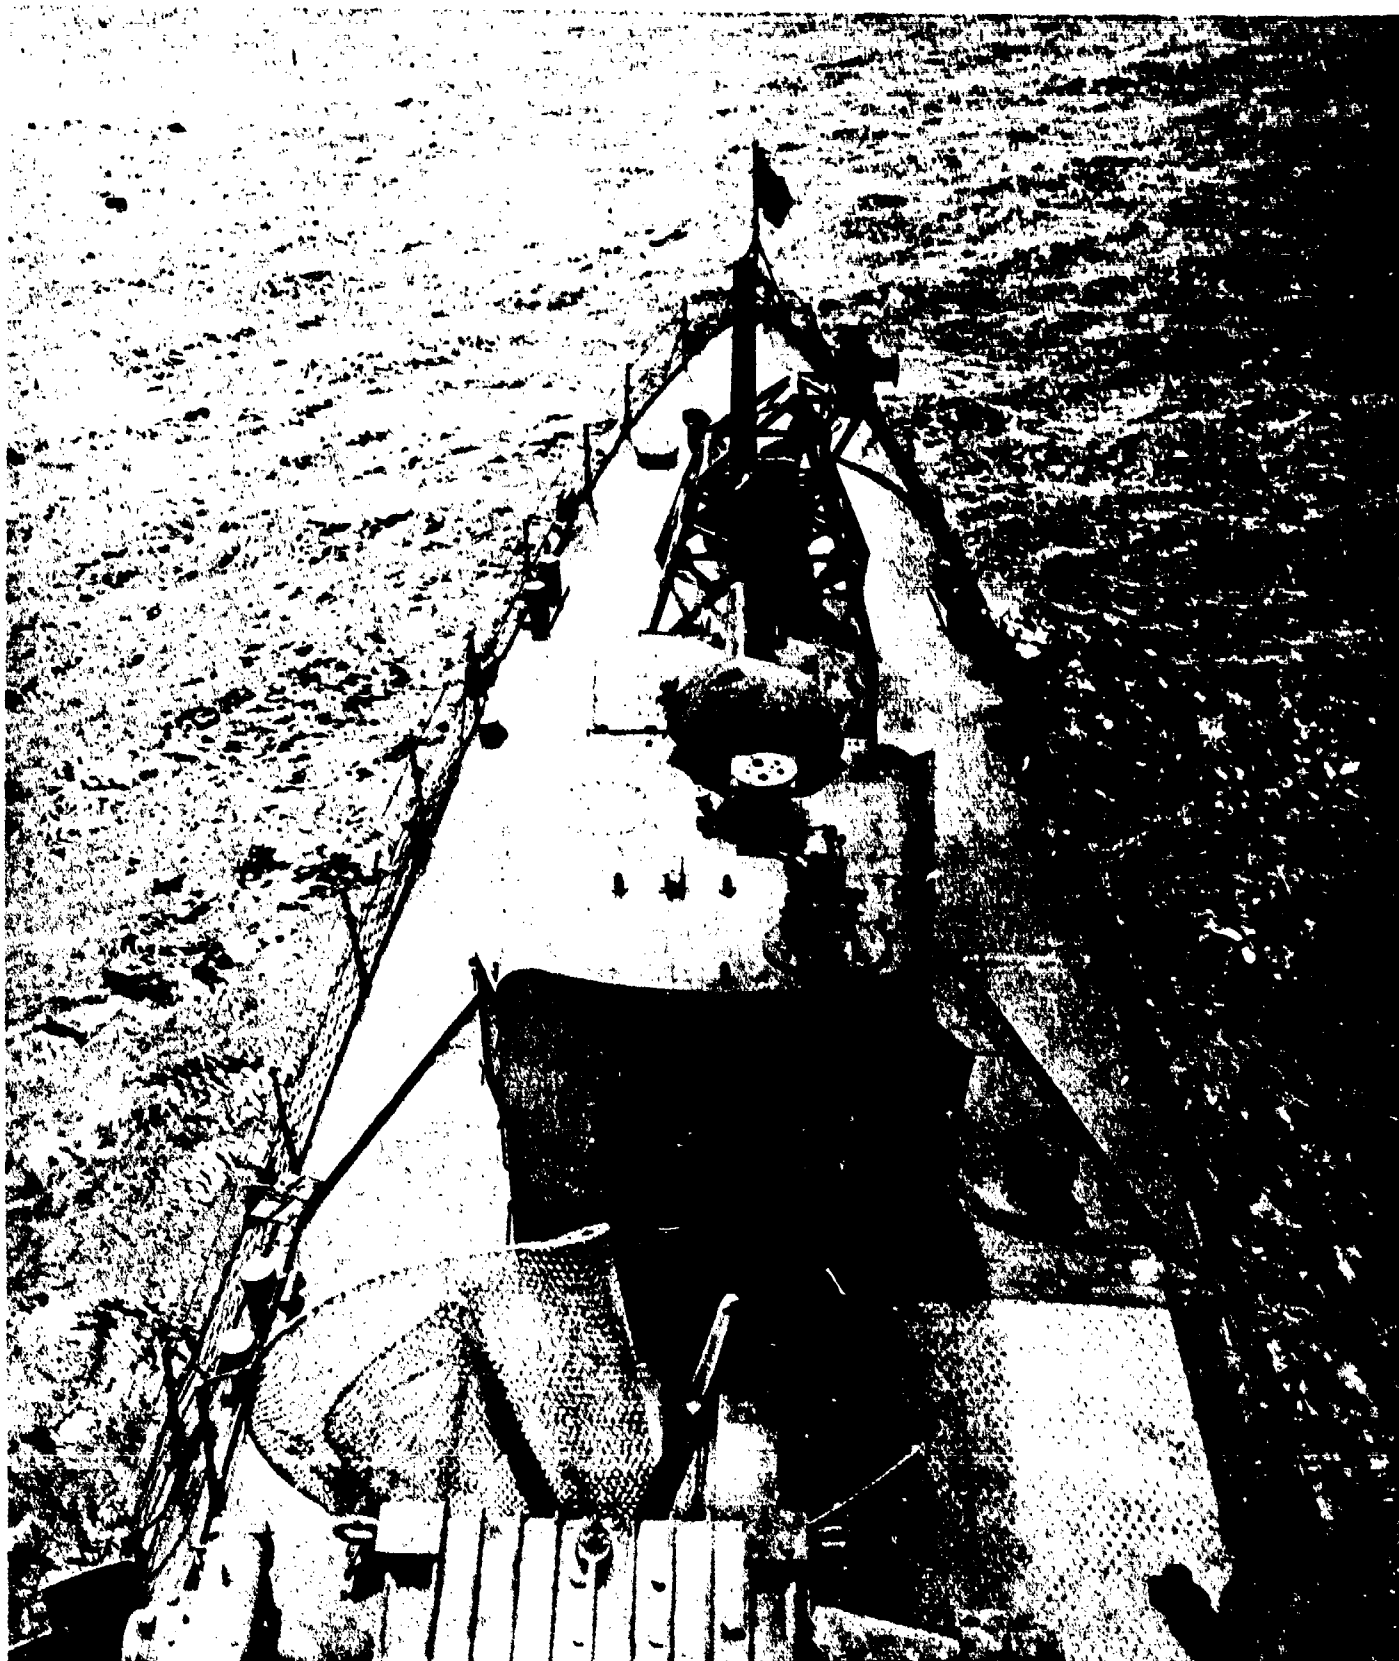
AA-CR-58-2003-3. View showing damage forward looking from sky look-out forward.

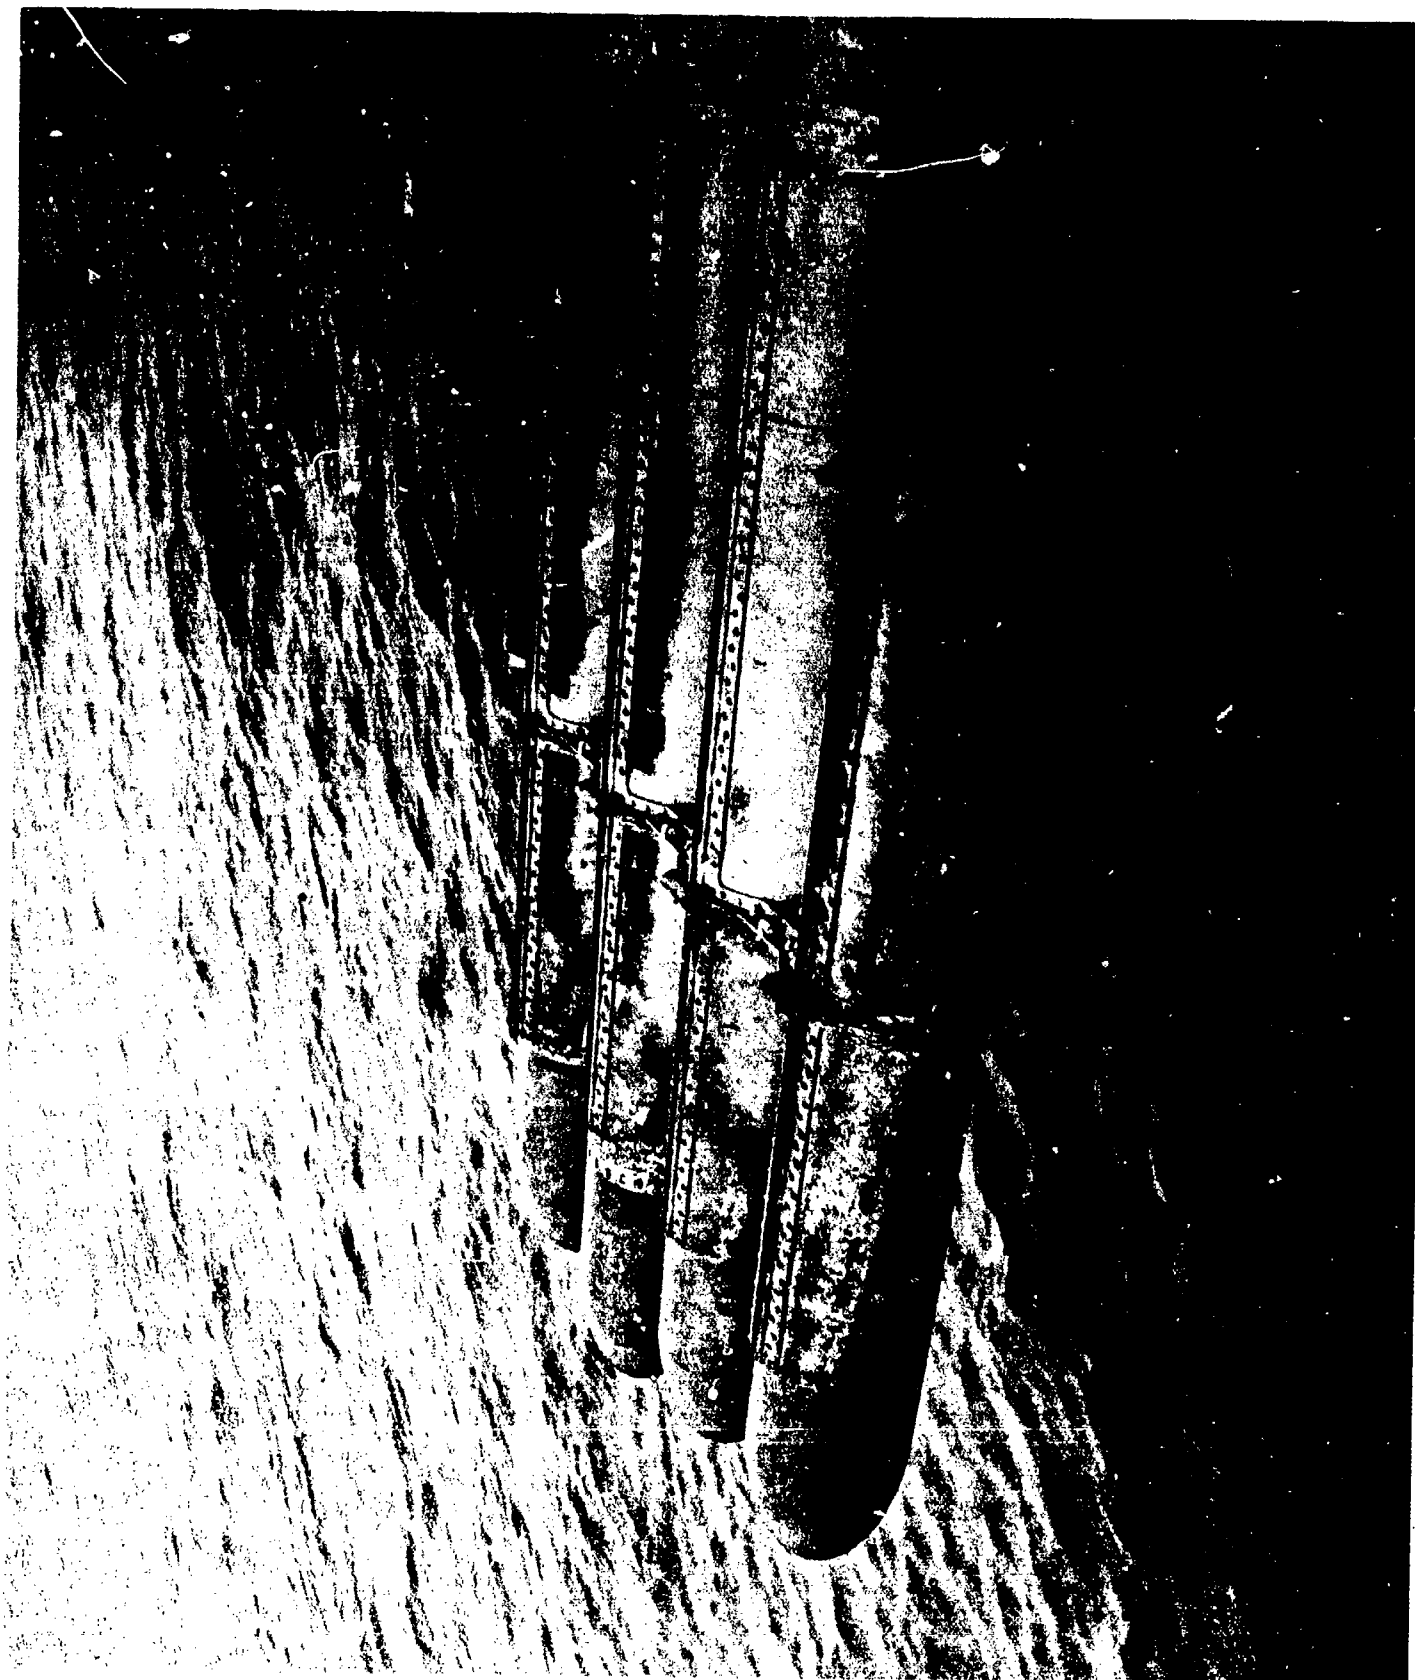
There is no material damage to the torpedo mounts. The torpedoes in the port mount, which was trained to 270 degrees, were knocked loose and now extend about three feet out from their normal position. This movement was caused by either the rapid roll and/or the high speed lateral displacement of the ship in the water caused by the blast pressure. The motion of the vessel and the inertia of the torpedoes produced a resultant force sufficient to break the tension lock holding the torpedoes in place. This force did not operate either the inertia starter or the starting lever. The torpedoes did not run and still have full air charges (photograph 1772-2, page 89 ).

AA-CR-92-1772-2. View looking aft along starboard side showing torpedoes extending from tubes as a result of Test A.

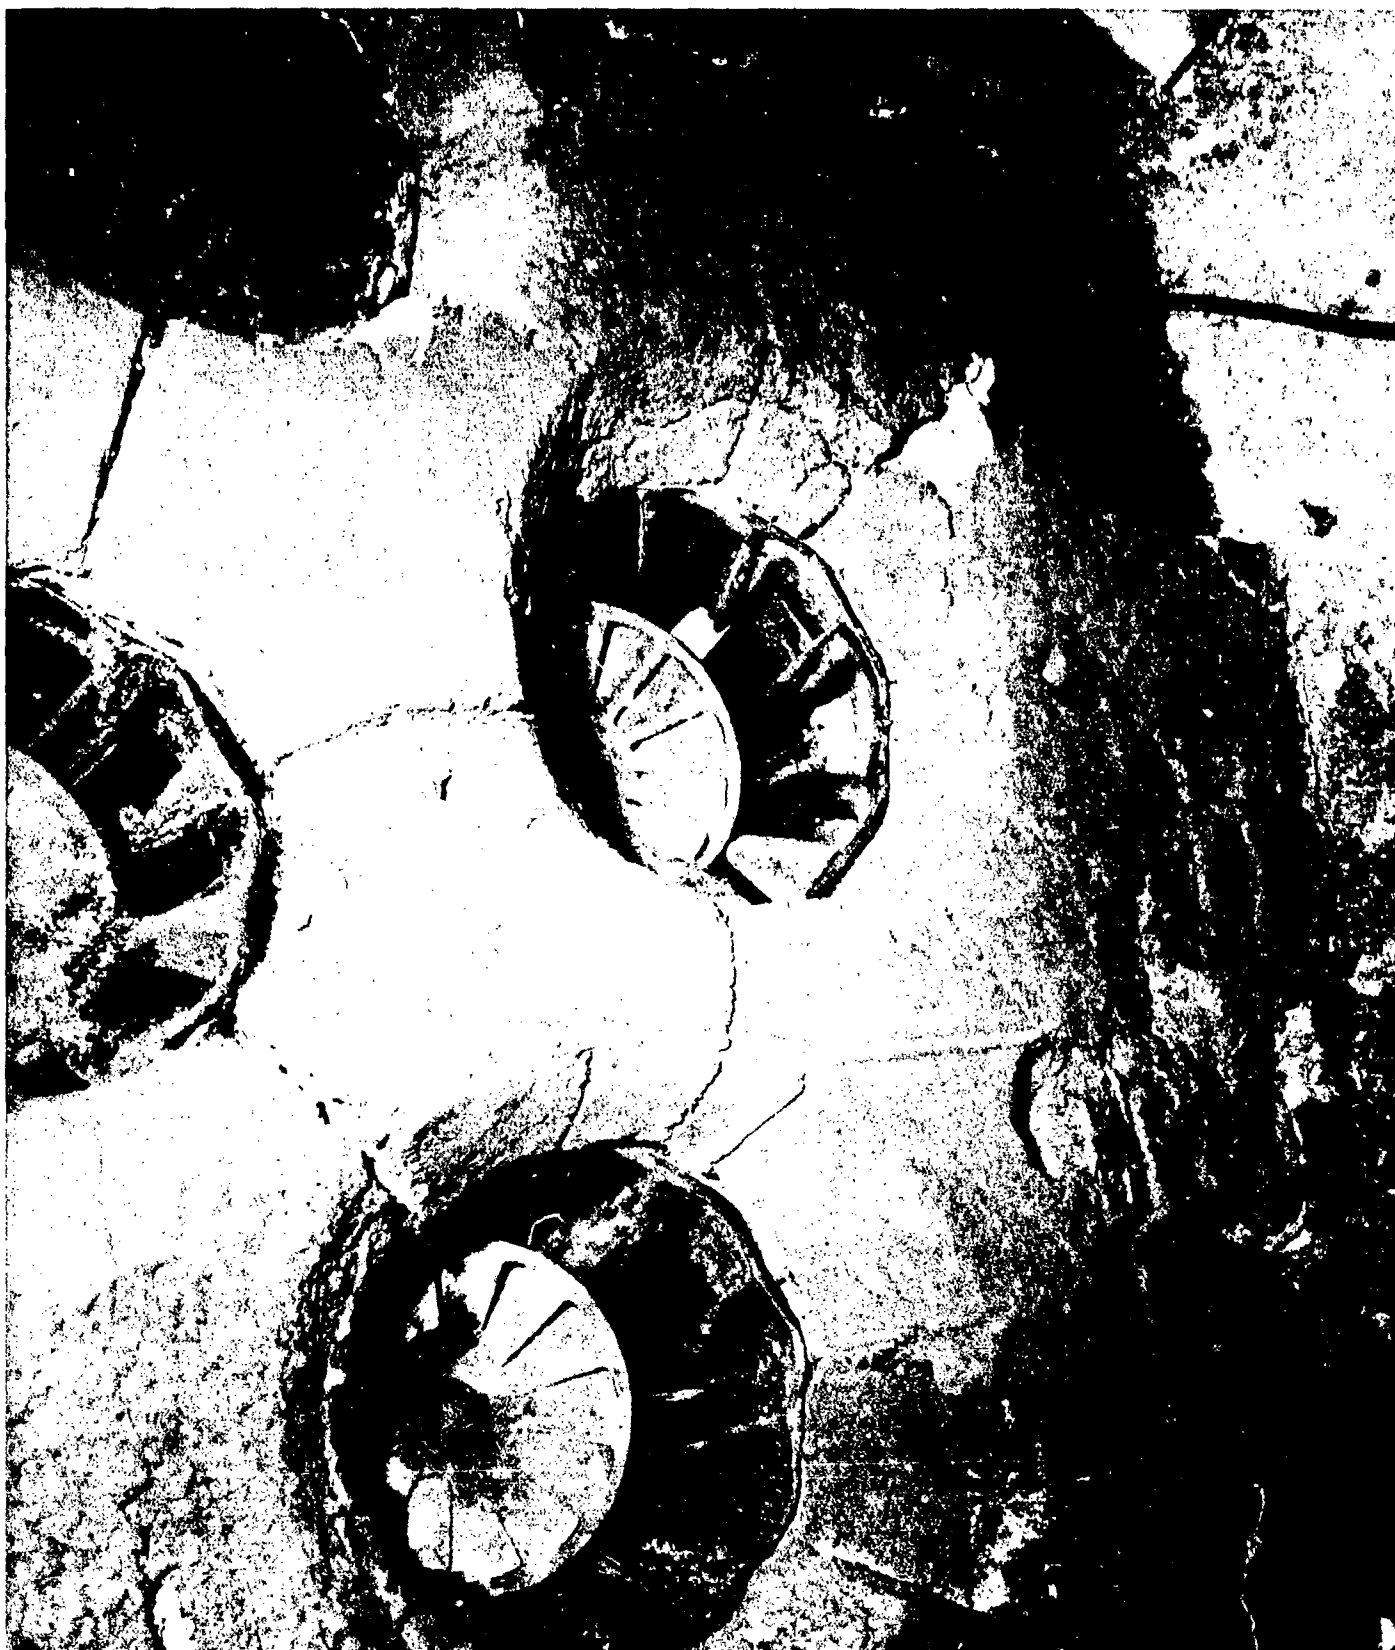
Boiler #1 is inoperable. Repairs to brickwork could be made by the ship's force in about 3 days. All other damage to machinery is minor and would not affect operation. Damage to the stack would prevent operation except at low speed and under favorable wind conditions, because of stack gasses entering the engine rooms' ventilation. Emergency repairs to the uptakes breeching and the stub stack requiring about 1 day would improve this condition, but not sufficiently to permit normal operation. The atmospheric exhaust line, which was bent over and flattened, had to be punctured to allow steaming of any boiler.

AA-CR-58-2003-8. No. 1 boiler cracked front wall.
